Fraunhofer Technologie-  
Entwicklungsgruppe

## Project report:

Oy RVS Technology Ltd.  
Pulittitie 2  
FI-00880 Helsinki  
FINLAND

## **Test of the validity of RVS-technology® gel**

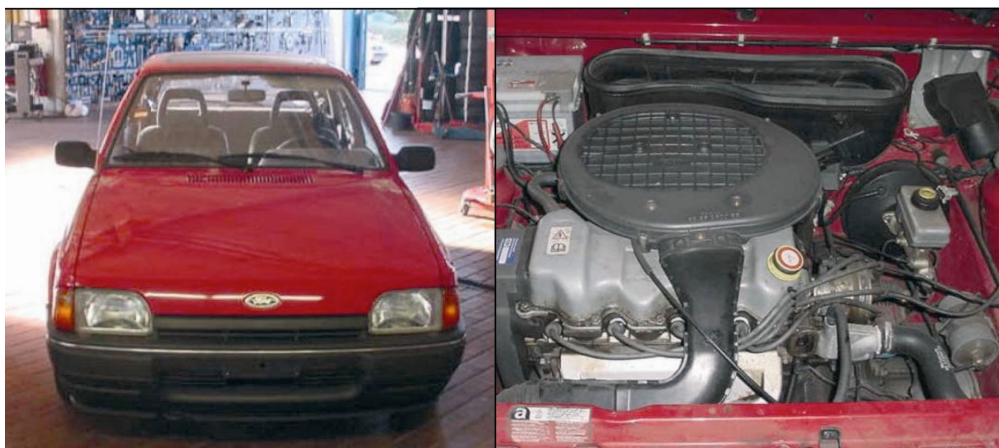
Figure 4-2: Ford Escort test vehicle, made in 1990 (vehicle on left, engine on right)

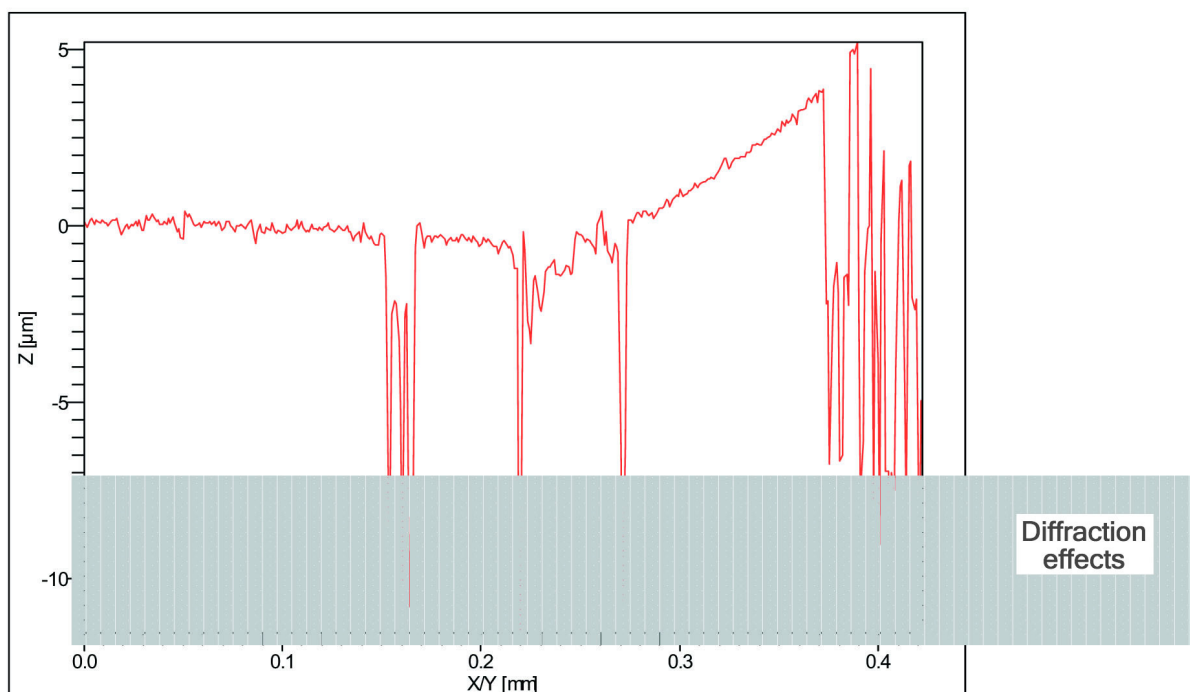
Figures 4-10 and 4-11 provide explicit representations of a cross-section quantifying the structure and course of the marks. These marks have a real depth of up to 8  $\mu\text{m}$ . Depths exhibited in excess of this value are attributable to the measuring inaccuracies (diffraction effects) of this technique ( $R_a = 6.6$  /  $R_z = 0.83$ ).

Figure 4-11: Recording of a cross-section by means of a white-light interferometer (zoom)

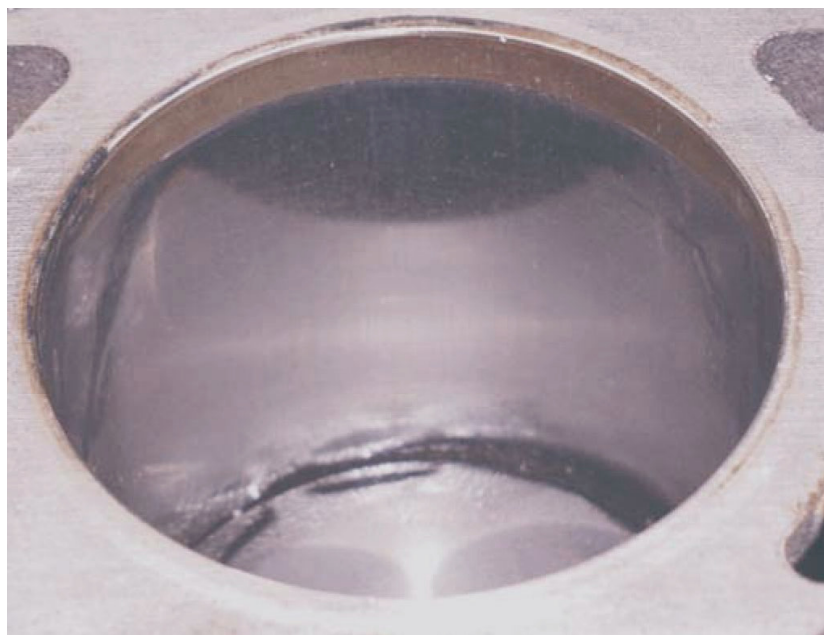
Figure 5-1: Digital recording of the Ford Escort's engine block following treatment (alterations to the surface are clearly visible)

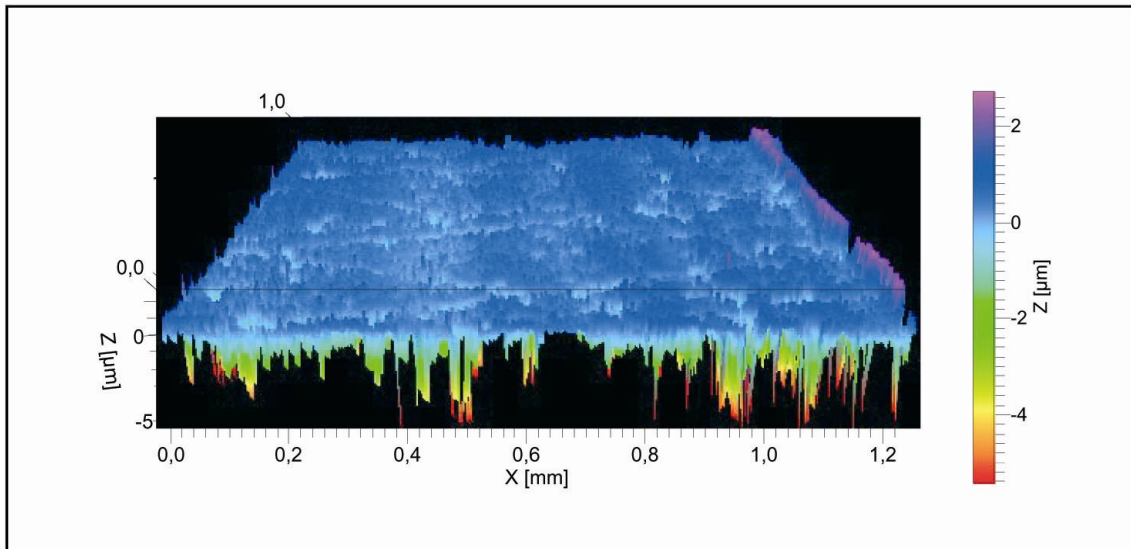
Figure 5-3: 3D recording of a cylinder wall using a white-light interferometer

Figure 5-3 provides a 3D representation of a cylinder surface recorded by means of a white-light interferometer. A corresponding top view of the surface is provided in Figure 5-4.

These recordings show the structure of the cylinder surface. Evidently, the surface has a typical, honed texture.

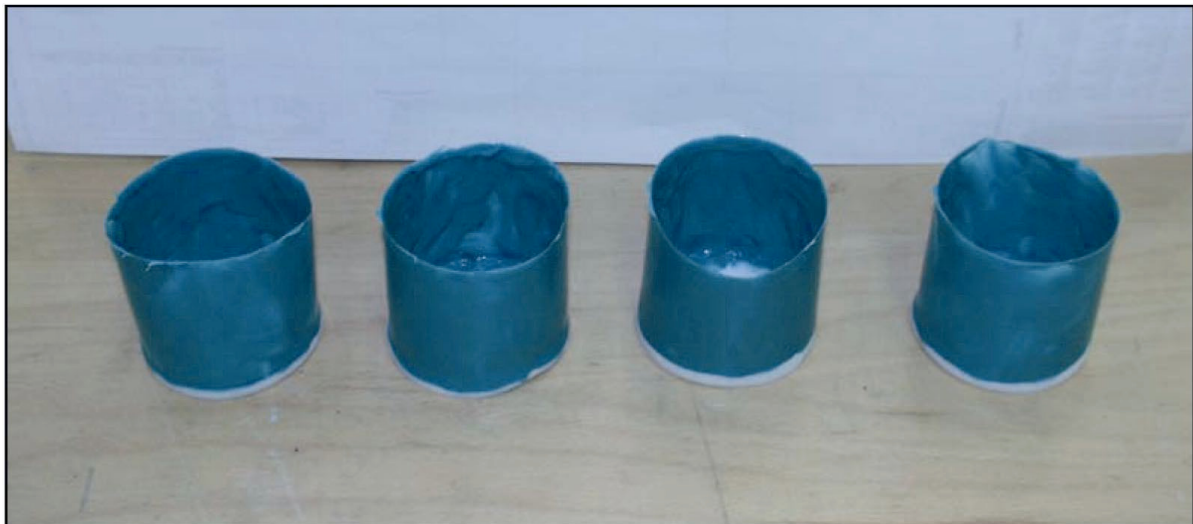
Figures 6-1 und 6-2 show the four cylinder casts before and after application of RVS-technology® gel.

Figure 6-1: Cylinder casts before treatment

This test is exclusively intended for a qualitative evaluation of changes in surface structure. The cylinder surface exhibited improvement in the form of reduced wear marks.

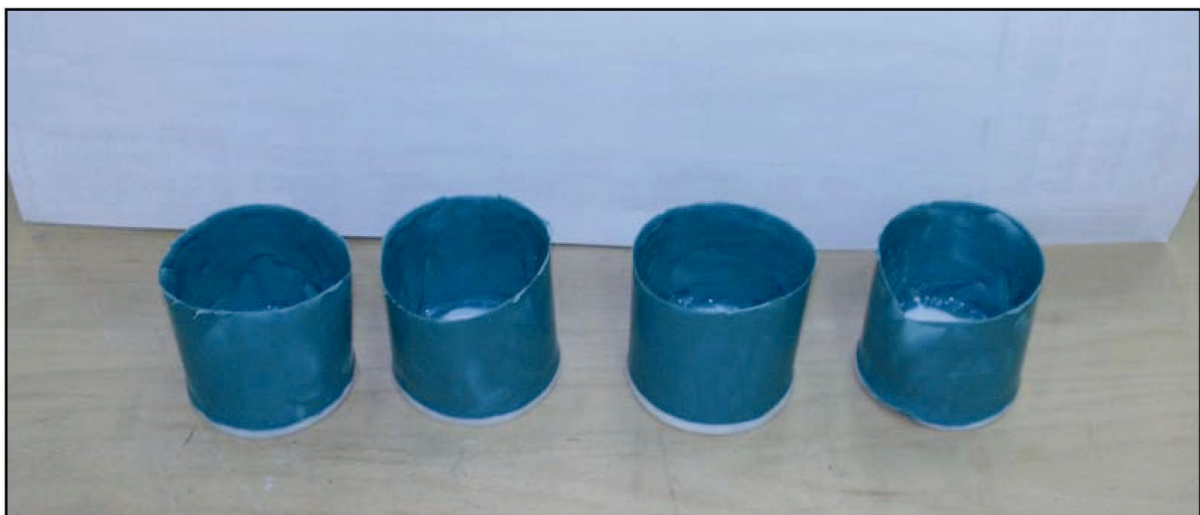
Figure 6-2: Cylinder casts after treatment
